STUCCO/EIFS

EDUCATION AND SOLUTIONS FOR REAL ESTATE

DEL-VAL HOME INSPECTORS INC.

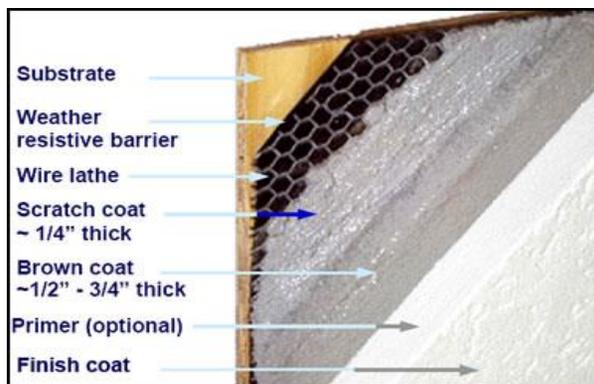
The most common type applied on residential homes in the Delaware Valley is Traditional Three-Coat Stucco. This consists of masonry or synthetic stucco which is applied over a wire lathe. This is also commonly referred to as a “Hard Coat”.

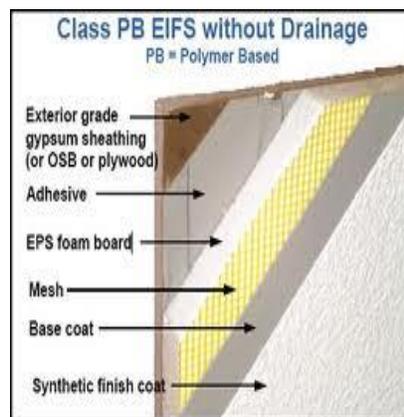
EIFS is a lightweight synthetic wall cladding system that includes foam insulation board covered by a thin synthetic finish coat. (Found more often on commercial buildings)

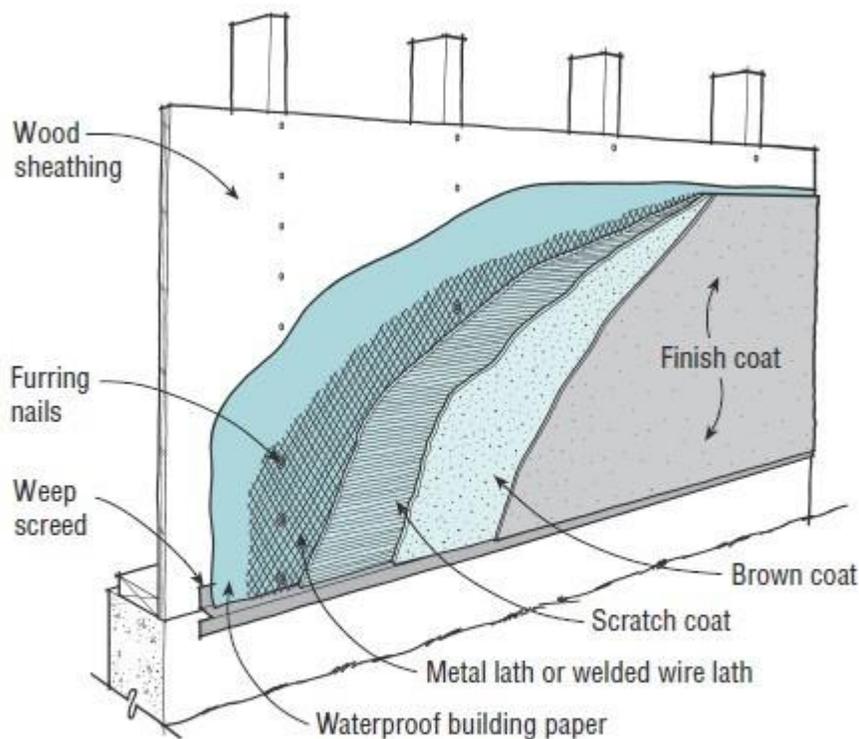
FIGURE 1-29 Three-Coat Stucco.

Traditional three-coat stucco is applied about $\frac{7}{8}$ inch thick over metal lath, which creates a space for water to drain out through the weep screed along the foundation. The drainage plane is essential since stucco itself is relatively porous.

One key feature found in some traditional Three-Coat and EIFS is a drainage system. The drainage system is created by a drainage track called a “weep screed”.

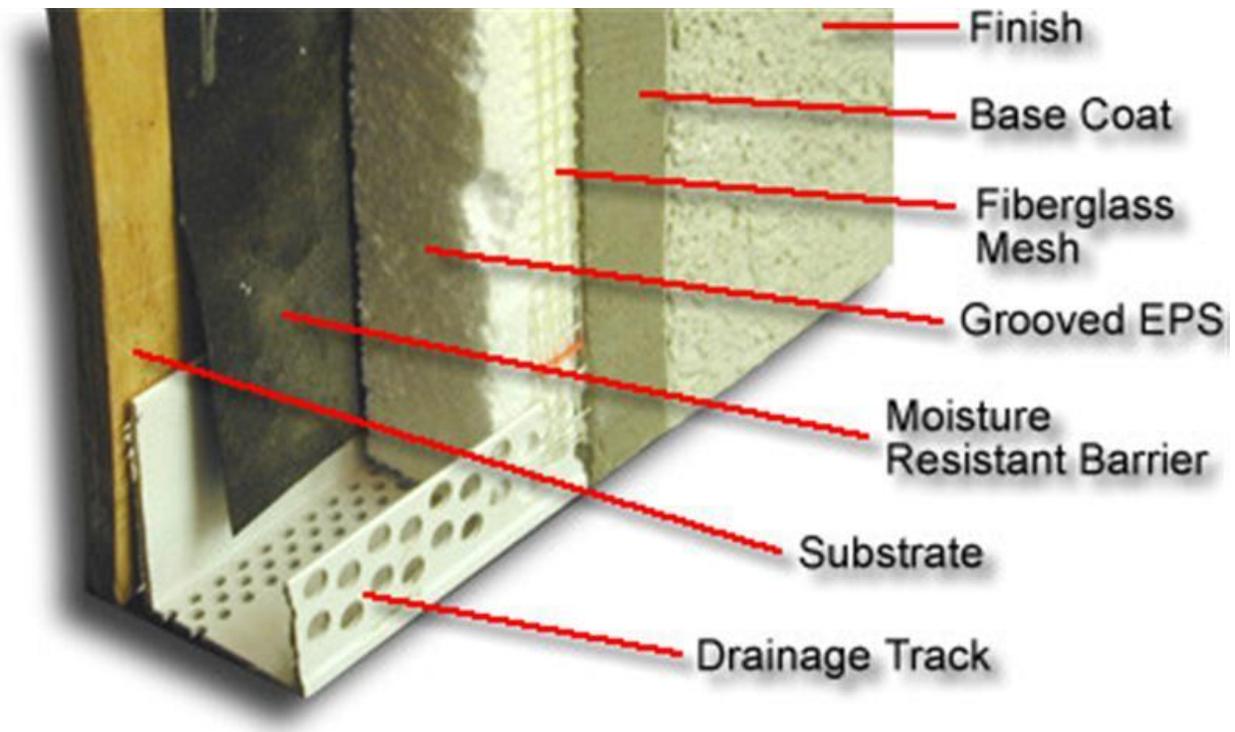
EIFS drainage System

EIFS with Drainage (Weep Screed) Shown above

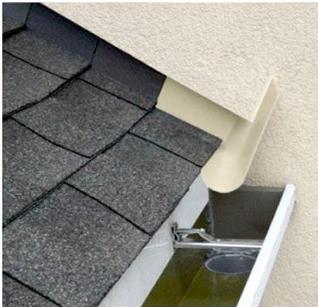
This image shows a proper Kickout Flashing installed with a proper termination gap between the stucco and shingles.

When the roof and stucco do not have proper flashing or the flashing is not properly installed, moisture can get behind the substrate. Missing Kickout Flashing is one of the largest issues found. When the stucco terminates too close to the roof, the moisture can wick up behind the stucco. Examples of both are shown in the pictures below. There is supposed to be a minimum of two inches between stucco and shingles. Kickout Flashings belong wherever a gutter terminates into a wall.

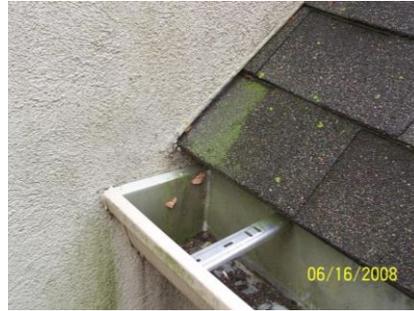
Missing Kickout Flashing, and touching shingles shown on left.

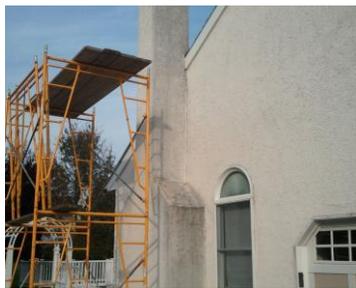
The relationship between the roof and a stucco chimney is a common concern.

Staining

and cracks are a common result.

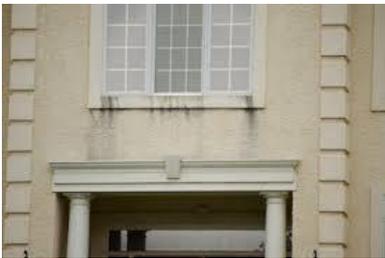
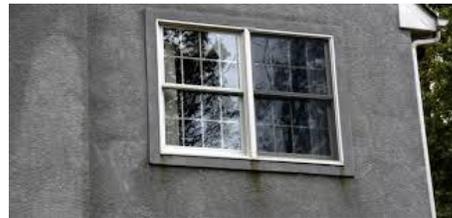
“Crying Windows”

Crying windows can also mean that the building envelope is crying for attention.

Another common issue occurs when windows are installed improperly or not flashed correctly. The relationship between the framing and the window is not something that is clearly visible. A term used for visible signs of water damage around a window of a stucco home is a “Crying Windows”. A crying window happens when the stucco below a window appears dark or discolored. This is not always from moisture penetration and sometimes can be from paint bleeding or metal accessories such as shutter nails rusting. A trained eye usually can tell the difference.

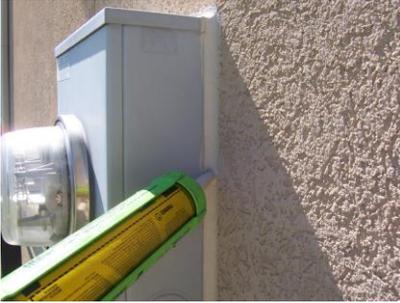
Properly sealing electric meter (all penetrations should be sealed)

Proper termination and caulking/sealing is another common issue. Caulk/Sealant is needed and maintained at all Windows, shutters, Doors, and Penetrations (such as hose bibs, electric, air conditioning, and natural gas line), and where dissimilar materials meet (such as stucco to vinyl siding or stucco to brick etc.) These areas should be terminated and sealed properly. Caulks and sealants breakdown over time and should have periodic evaluations as part of routine

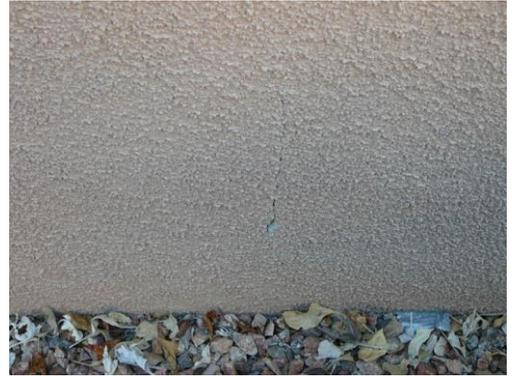
Cracks can allow moisture behind substrate.

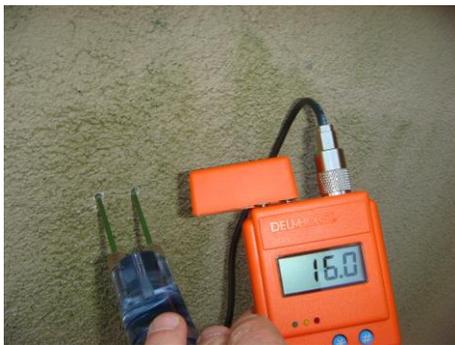
Inspector will drill
3/16-1/4 inch holes

Moisture probe will be applied for reading.

The second type of inspection is an invasive inspection. This is where the inspector drills small holes and probes the substrate with a moisture meter to check for the moisture content. Typically wood substrate in a normal functioning wall will read anywhere from 6%-12%. Readings from 15%-19% are marginal. Water is getting in, but not likely to cause extensive damage yet. Preventative maintenance actions are required to prevent further damage. According to the American Plywood Association, readings at or above 20% moisture content in wood promote mold growth and wood rot. Areas above 20% should be remediated. The stucco and affected areas should be removed until

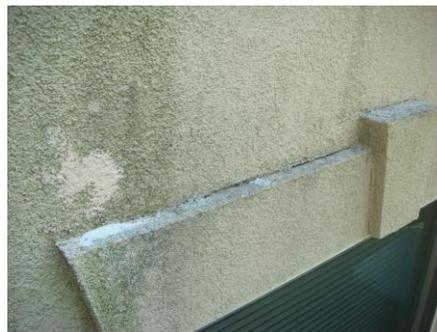
After the reading is taken the
then use color match caulk to

Inspector will
seal holes.
